[Index](#)
HP 4500® OPC/Waste Remanufacturing Instructions

Oasis Imaging Products, Inc. Technical Support: (888) 627-6555

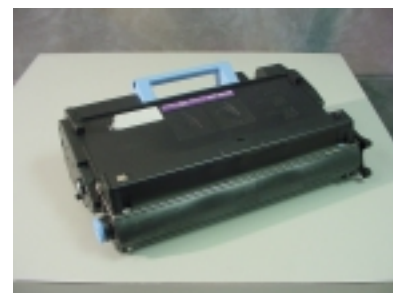
1. Remove one screw securing the spring loaded drum shutter actuator arm. Remove the spring from the actuator arm. The actuator spring is tension loaded into the actuator arm and may dislodge and become lost.

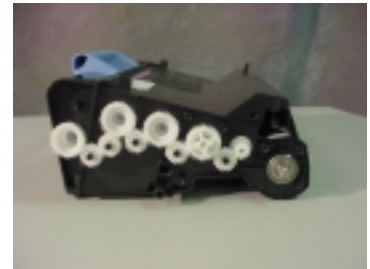
Remove the five sweeper blade agitator gears and axles. Note the position of the gears as well the position of the sweeper blades. The agitator gears and axles are notched and positioned specifically with the internal sweeper blades. *See lower diagram for sweeper blade positions.

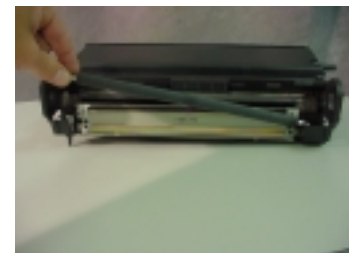
7. Lift the pcr by the metal shaft and remove from cartridge.

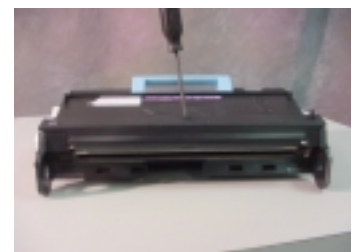
8. Turn the cartridge over, use a flat head screwdriver to remove the plastic drum cover.

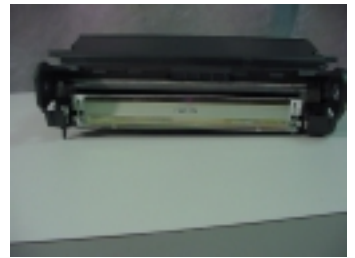
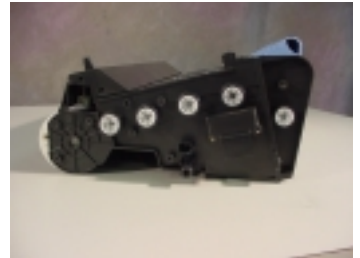
10. With the drum and the pcr you can now remove the wiperblade. You will notice the wiperblade had mounted on the lower front metal stamping, a gold colored bar. This bar is attached by double side tape to the metal stamping. There are also two machine screws attached to the bar through elongated holes in the bottom of the wiperblade stamping.
11. Inspect mylar recoveryblade for wear and loose ends. Replace if worn, loose or wavy.
12. Inspect drum foams for toner adhesion and looseness.
13. Clean PCR saddle clips and electrical contact.
