# Lexmark E310

# Remanufacturing Instructions

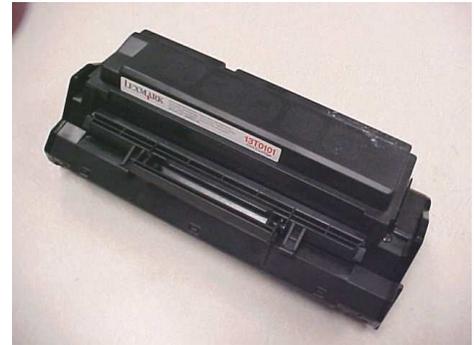
1. Remove the two screws on the top of the toner cartridge shell (Fig 1).
2. Locate the three plastic locking tabs on the front of the cartridge. Gently pry them apart with a small flat-head screwdriver (Fig 2).

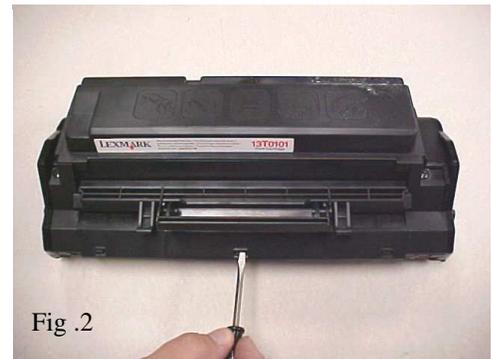
3. Remove cartridge lid. CAUTION, if there is any toner left in the hopper it will spill out. Vacuum out any residual toner from the cartridge interior (Fig 3).
4. Remove the three screws from the end plate on the non-gear side of the cartridge (Fig 4).

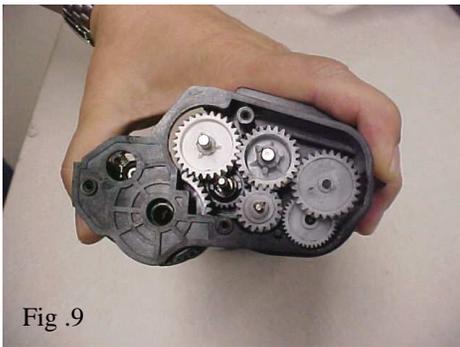
Fig .9

- 9. Note the gear orientation, these will have to be removed to complete the remanufacturing process (Fig 9)
- 10. Remove the two screws on each end of the PCR cradle and remove the PCR assembly. It is possible to clean the PCR while it is still assembled in the cradle, do not remove the drive gear and be careful not to lose the compression springs located at the end of the PCR assembly (Fig 10).

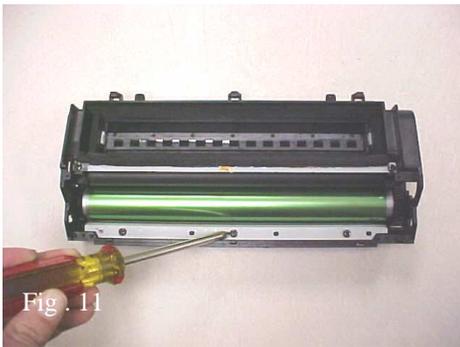
Fig . 11

- 11. Remove the three screws that hold the wiper blade in place then remove the wiper blade. CAUTION: The urethane strip on the bottom of the wiper blade is easily damaged, do not bend it(Fig 11).
- 12. Remove the OPC by pulling it out by the large helical drive gear (Fig 12).

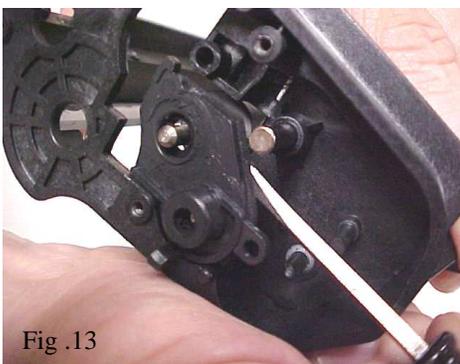
Fig .13

- 13. Pry off the developer roller /sponge roller stabilizer plate located in the gear housing (Fig .13).
- 14. Carefully slide the developer roller out of the opening, do not scratch it or handle the surface with your fingers (Fig .14)

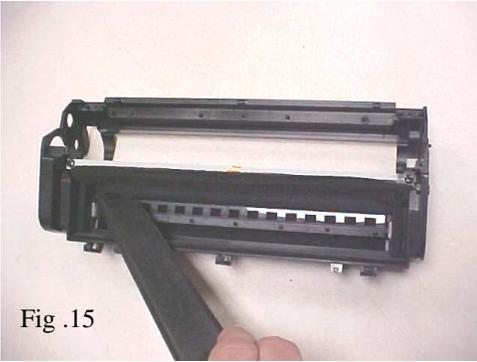
Fig .15

15. Vacuum out all excess toner , particularly the sponge delivery roller. Also wipe off the working edge of the Dr. Blade with a lint free cloth. Reassemble in reverse order, filling the toner hopper before putting cartridge lid on (Fig .15)  
 16. Individual cartridge components after removal (Fig .16)
