HP® 1300 Remanufacturing Instructions

Reference Information:
Q2613A
Q2613X

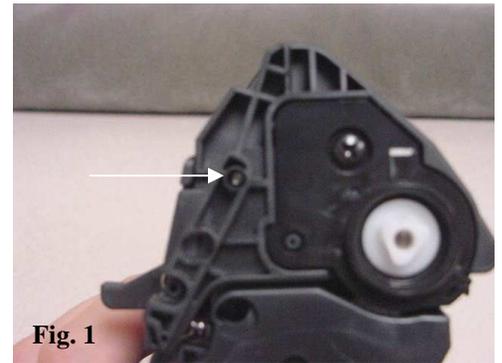
Fig. 1

1. The cartridge halves are held together by a pair of retaining pins (Fig.1); one on each end of the cartridge. The cartridge pins will cause damage to the PCR cradle if pushed in; therefore they must be removed from the inside and pushed out. The method of removal in these instructions will cause some minor damage to the cartridge shell, but will not be visible to the end user.

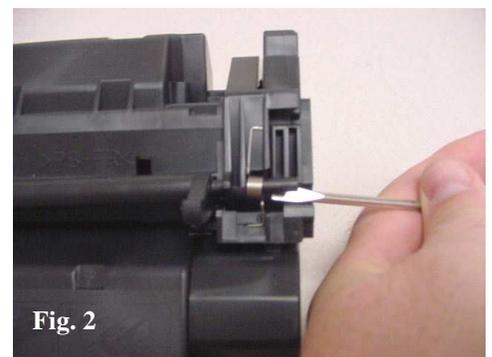
Fig. 2

2. Using a small flat head screwdriver, gently pry up on the door hinge with the spring to remove the drum shutter door from the waste bin (Fig. 2). Do the same to the opposite door hinge and carefully remove the shutter door.

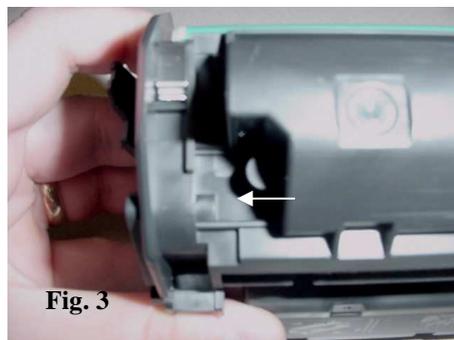
Fig. 3

3. Once the shutter door is removed you can see the area on figure 3 & 4 that needs to be drilled, so that you can push the cartridge pins out.

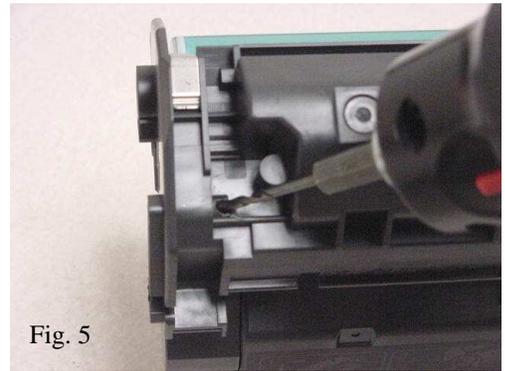
4. Using a 3/32" drill bit carefully drill a small hole into the plastic housing where the cartridge pin is located (Fig. 5). Repeat this process on the opposite side of the cartridge where the second cartridge pin is located (Fig. 6).

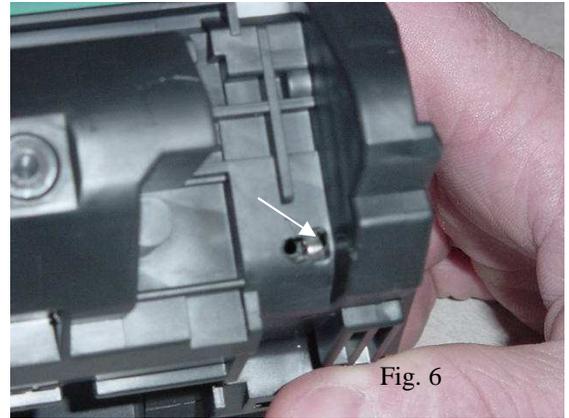
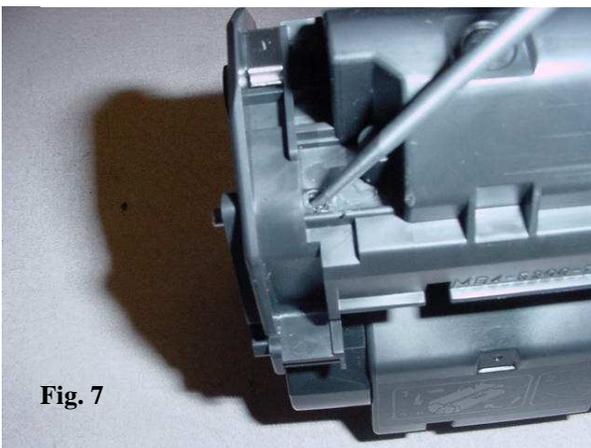
5. Once the holes are drilled in the cartridge pin locations you will be able to see the end of the cartridge pin. Use a small punch or angled tool to push the pin out from the inside of the cartridge (Fig. 7).

Push the pin out enough so that you can get a pair of pliers on the pin once it is free from the internal housing to fully remove it. Repeat the same steps on the opposite pin (Fig. 8).

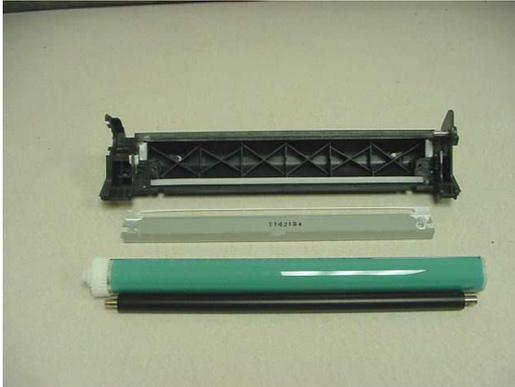
Fig. 12

9. Remove the two screws that secure the wiper blade (Fig 12). Remove the blade and replace if necessary. Remove all residual toner from the waste bin. Check Mylar recovery blade and ensure that it is not creased or damaged. Clean or replace PCR and OPC and reassemble in reverse order.

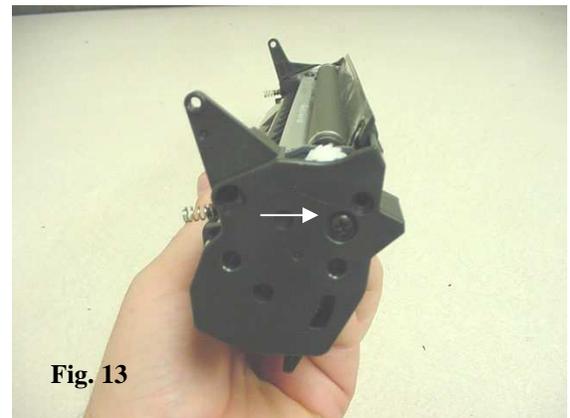
Fig. 13

10. Remove one screw from the end cap on the gear end side of the toner hopper (Fig. 13).

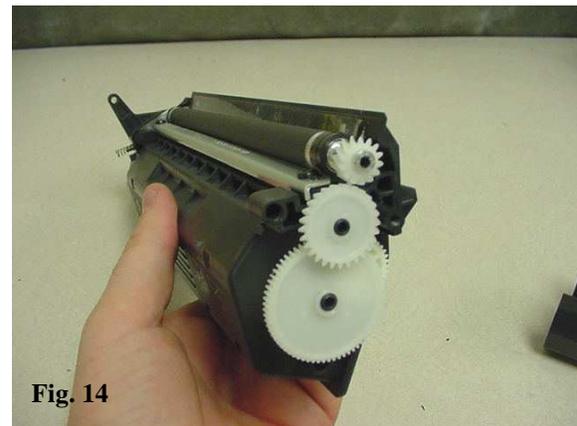
Fig. 14

11. Once the end cap is removed remove the gears from the toner hopper. Make a notation of the position of the gears for re-assembly (Fig.14).

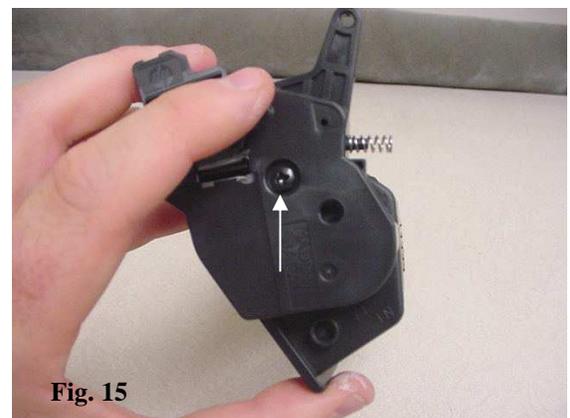
Fig. 15

12. Remove the one screw on the mag contact end cap on the opposite side of the toner hopper (Fig. 15).

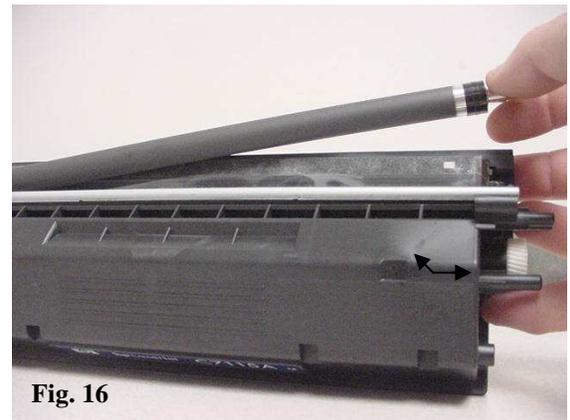
13. Carefully remove the magnetic roller by lifting the roller from the toner hopper section (Fig. 16). Note the location of all peripheral components on the mag roller (bushings, etc). Use compressed air to remove all residual toner from the surface of the sleeve and inspect for damage.

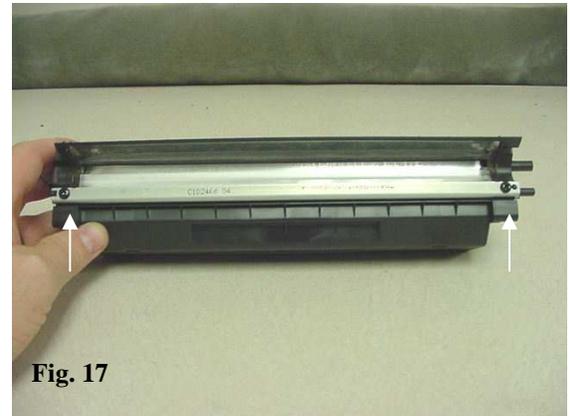
14. Remove the two screws that hold the doctor blade in place (Fig. 17). Use compressed air or a vacuum to remove the residual toner from the blade; replace if necessary. Inspect the mag roller Mylar for damage; replace if necessary. Clean the hopper with compressed air or a vacuum; clean the hopper of all residual toner. Fill the toner hopper with the required gram load and prepare for re – assembly.

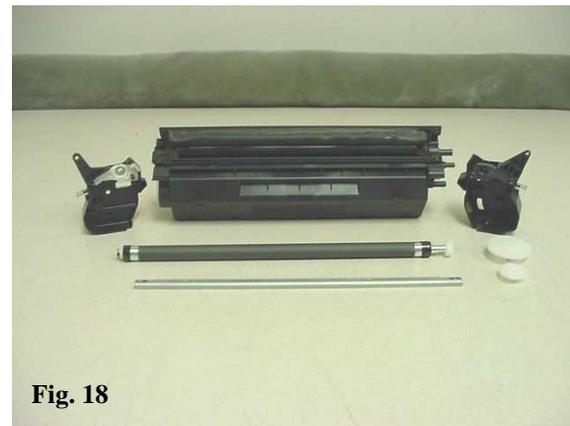
15. Reassemble the toner hopper in reverse order of the disassembly. Clean and inspect all components and replace if necessary (Fig. 18). Place the cartridge halves together and avoid damaging the springs on the top of the toner hopper. Align the pinholes on each side and insert the cartridge pins to hold the halves together.
